Name Of Dam: UPPER NORTON RESERVOIR DAM

Location: WISE COUNTY, VIRGINIA

Inventory Number: VA 19508

PHASE I INSPECTION REPORT NATIONAL DAM SAFETY PROGRAM

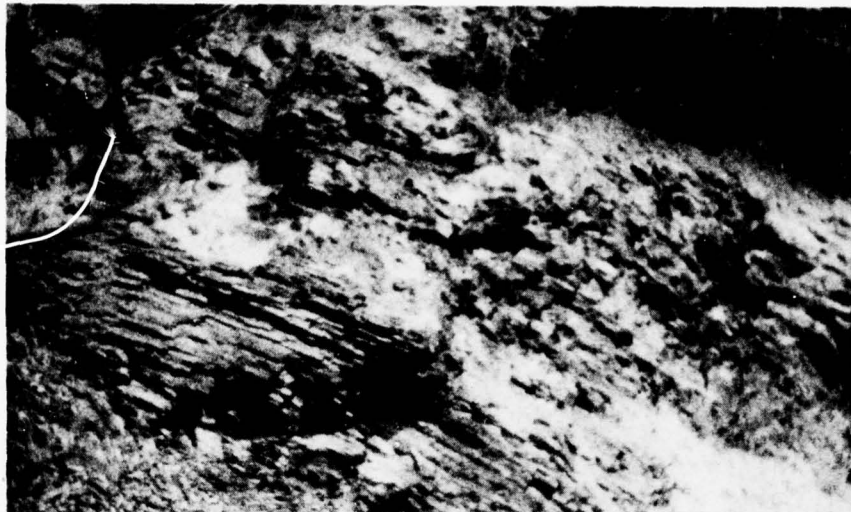
3.1.3 Reservoir Area: The reservoir shoreline was densely wooded and no major active landslide areas could be seen. However, a small shallow slide (see photos - Appendix II) was observed on the west shoreline about 400 feet from the spillway weir. The width of the slide area was approximately 25 feet, and its depth 3 to 4 feet. The length of the slide was approximately 60 feet upwards from the waterline, with the bank sloping approximately 2.5 horizontal to 1.0 vertical. The exposed material at the top of the slide area was visually identified as weathered soft shale comprised predominantly of silt with little clay. The clay fraction appears to be lean. The slide appeared to have occurred recently. This was confirmed by the City Manager who reported the slide occurred in 1977. Similar material was observed exposed along the west shore near the overflow weir. The shoreline slopes on the east side were relatively flatter and stable.

CLOSE-UP AT TOP OF SLIDE. NOTE: EXPOSED LAYERS OF
WEATHERED SOFT SHALE

7.2.2 The owner should obtain all existing computations for stability of the slopes adjacent to the spillway of this dam within 30 days of receipt of this Report. The potential for blockage of the spillway inlet by fallen and floating trees as well as slope failures should be investigated commencing within 30 days.

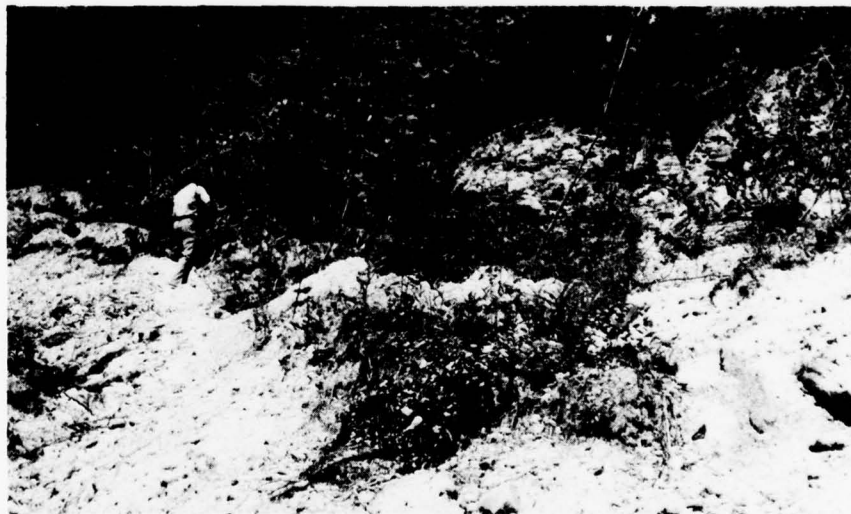
VIEW OF TOP AREA OF SLIDE

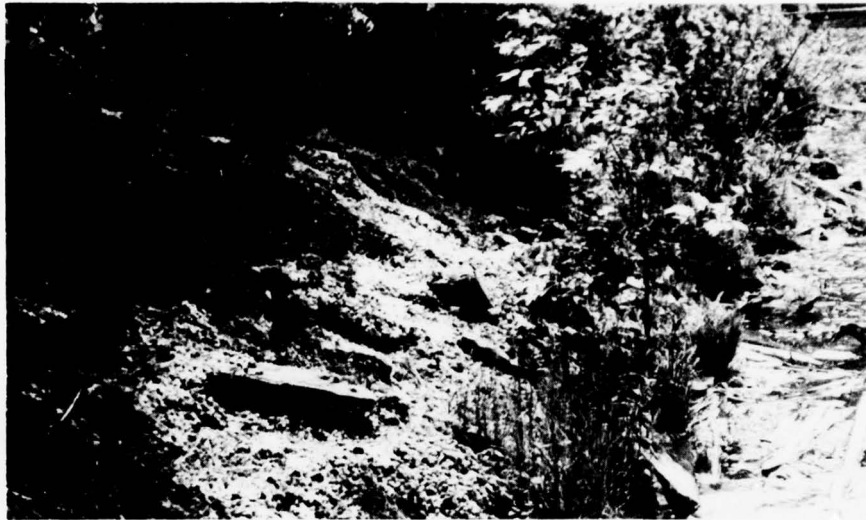
GROUTED RIPRAP ON UPSTREAM FACE OF LEFT ABUTMENT

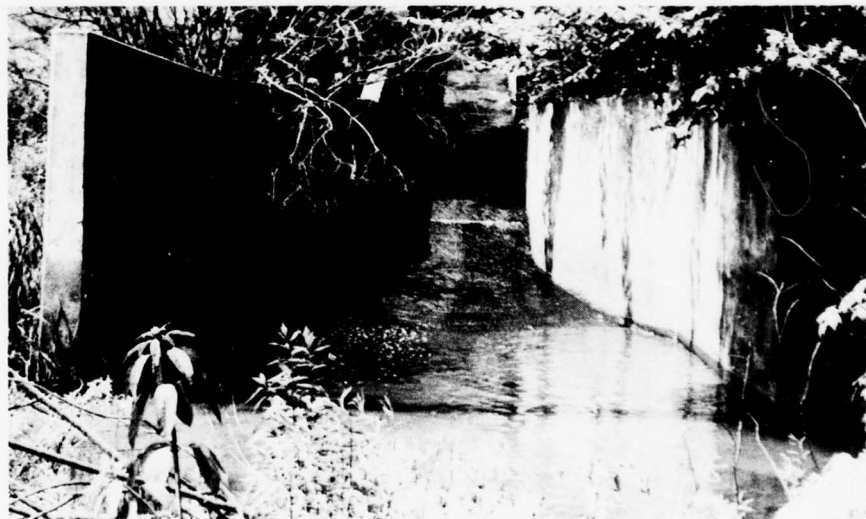
SPILLWAY OUTLET - LOOKING UPSTREAM

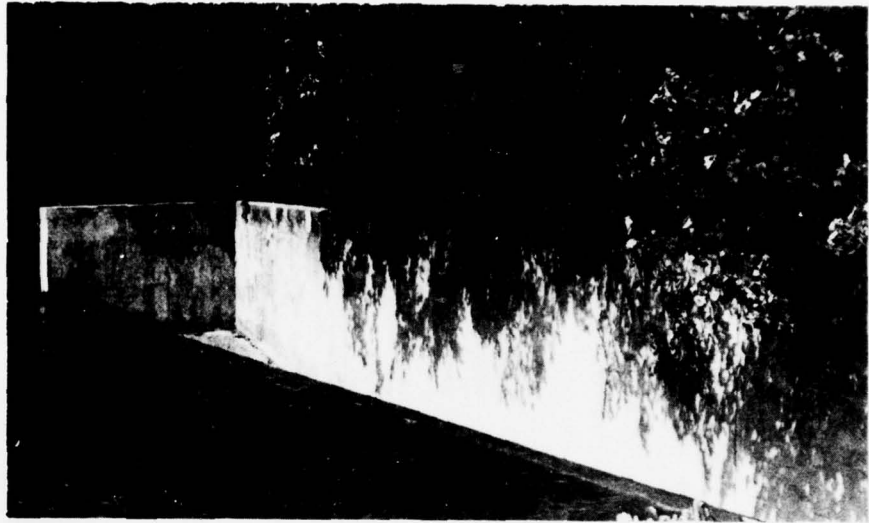
3.1.2.3 Appurtenant Structures: The overflow weir and the spillway dimensions that were checked agreed with the plans. No significant displacement, tilting, or cracking of these structures was observed except for a relative displacement of about 1-1/2 inches at the top of the right (damside) wall of the spillway at station 0 + 50 on the plans. Expansion joint material was partially extruded at several vertical joints in the spillway channel. There was some surface spalling or scaling of the concrete at the discharge point of the 30-inch culvert. Excessive tree growth was observed behind the spillway walls.

OVERFLOW WEIR - NOTE GROWTH OF TREES

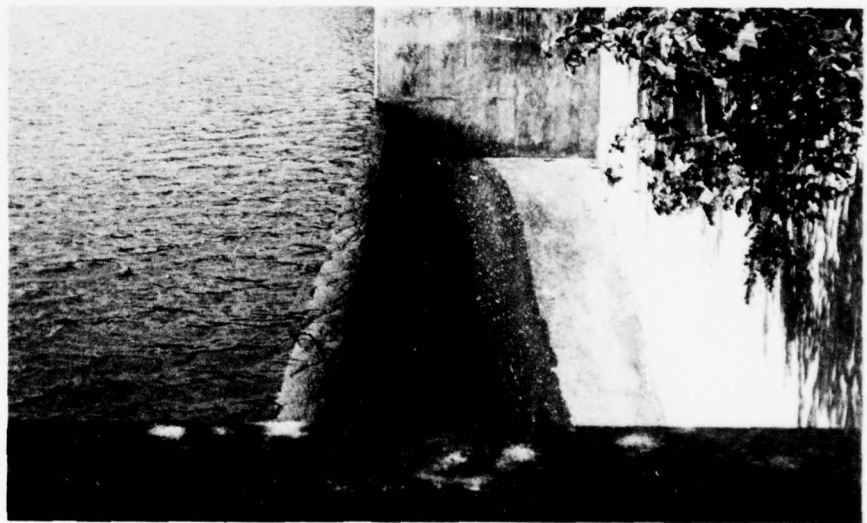
OVERFLOW WEIR - NOTE WATER FLOWING OVER THE WEIR

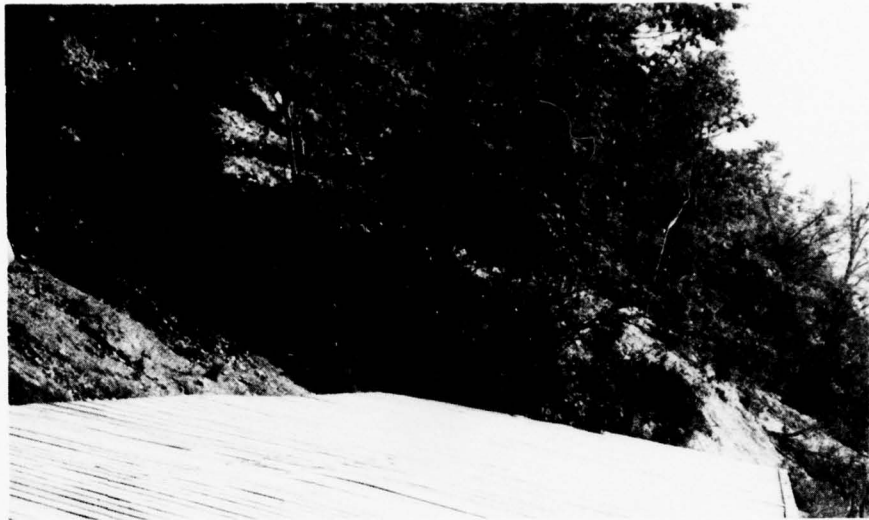
7.1.1 A minor slope failure had occurred on the reservoir shoreline within several hundred feet of the principal spillway.

RESERVOIR SHORE LINE SLOPE FAILURE

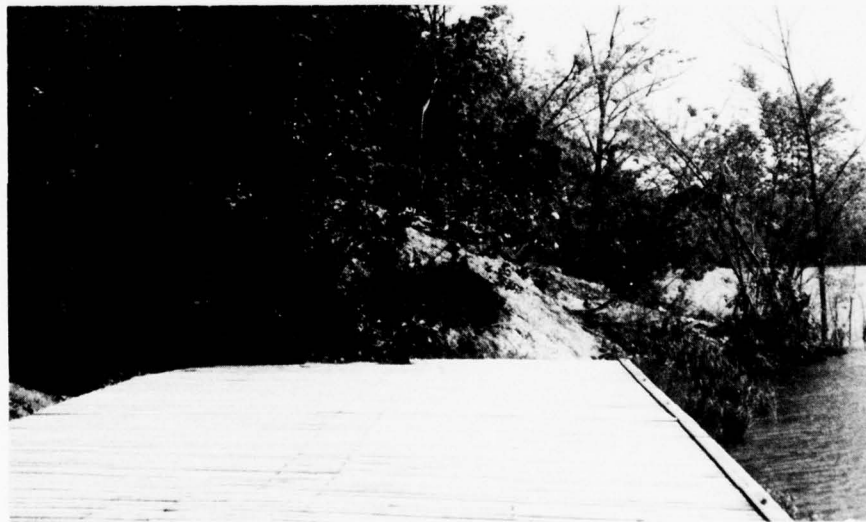
SLOPE FAILURE AREA NEAR BOATING DECK -
NOTE EXPOSED MATERIAL

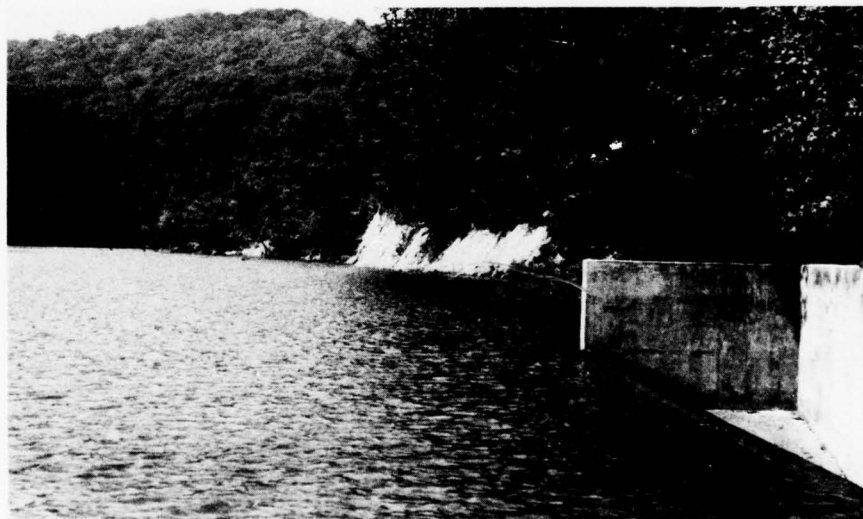
EXPOSED SLOPES AND OVERFLOW WEIR,
NOTE SLOPE FAILURE AREA IN BACKGROUND

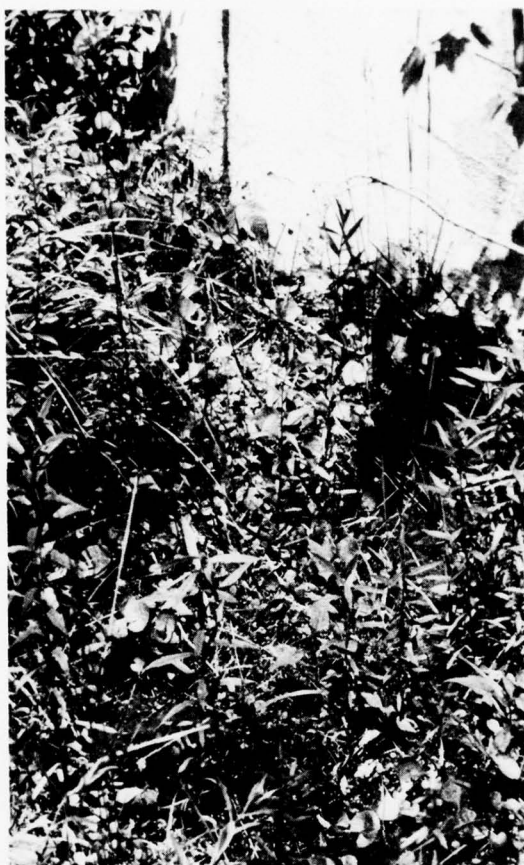
NOTE LEAKAGE FROM SPILLWAY AREA

VISUAL EXAMINATION OF	OBSERVATIONS	REMARKS OR RECOMMENDATIONS
JUNCTION OF EMBANKMENT AND ABUTMENT, SPILLWAY AND DAM	Generally satisfactory. Small seepage at junction of spillway and dam embankment.	The source of seepage should be determined.
ANY NOTICEABLE SEEPAGE	See above	
STAFF GAGE AND RECORDER	None	
DRAINS	None visible in embankment.

7.2.4 The source of the seepage at the spillway-embankment junction and the erodibility of the contact zones should be investigated with a monitoring program within 90 days. It is further recommended that the owner obtain all existing computations regarding design and allowable seepage through the dam within 60 days of receipt of this Report.

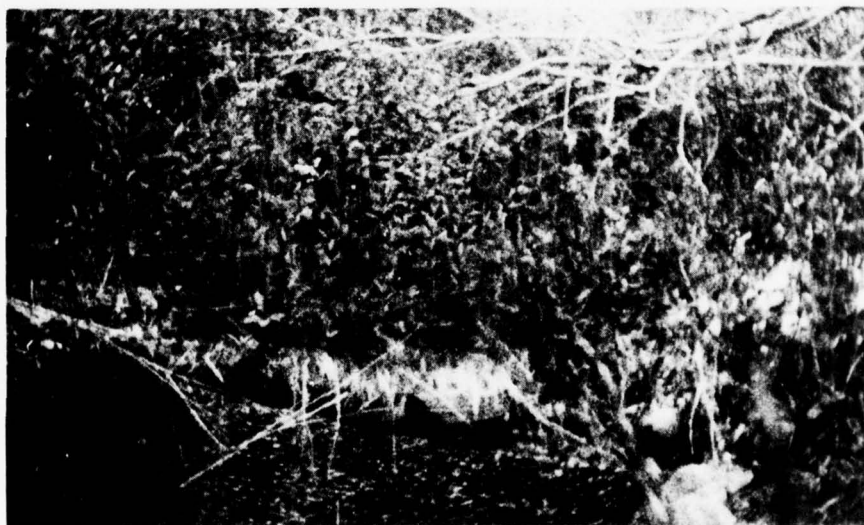
NOTE LEAKAGE FROM SPILLWAY BASE

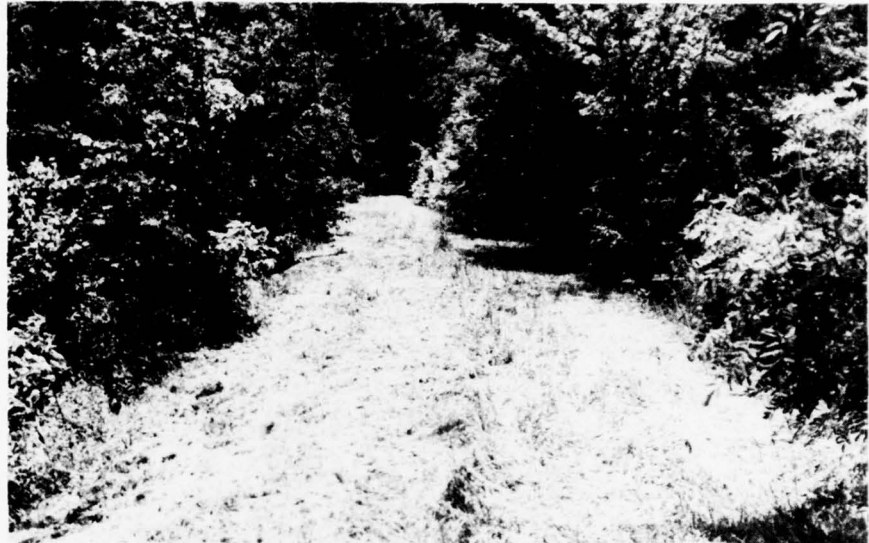
3.1.2.1 Dam: Significant portions of both the upstream and downstream slopes were covered with a dense tree growth. Many trees were 30 to 40 feet tall with trunk diameters up to 9 inches. No areas of significant settlement were observed. Several small erosion gullies up to 6 inches deep were observed near the downstream toe; the gullies were vegetated except for a few bare spots. The surficial embankment soil was brown, silty, fine sand with a trace to little clay. The visible upstream riprap was generally slab shaped siltstone and/or sandstone rock 2 to 4 inches thick, and varying in width and length from 2 inches up to 3 feet. Much of the riprap was covered with vegetation and there was some minor dislocation of stones as shown in the photographs. A portion of the riprap adjacent to the spillway was covered with cement grout. The slopes and dam crest were generally uniform and in agreement with the slopes and dimensions shown on the design drawings.

TOP OF DAM LOOKING TOWARD RIGHT ABUTMENT.
NOTE: TREES GROWTH ON BOTH UP AND DOWNSTREAM FACES OF DAM

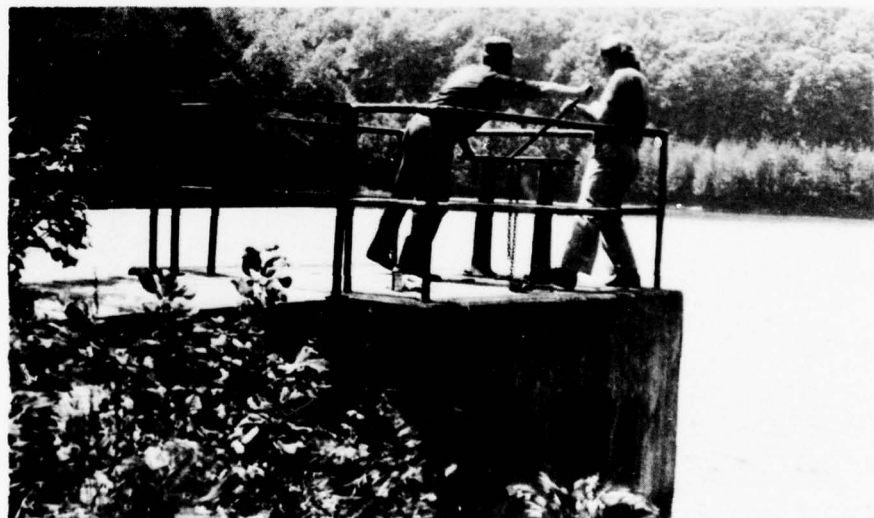
OPERATORS FOR THE VALVES - NOTE RIGHT
SIDE VALVE BEING OPERATED
